# Refurbishment of Corroded Basket Strainer

<b>Industry</b>	Power Generation
<b>Date</b>	February 2018
<b>Substrate</b>	Steel
<b>Products</b>	Epo-Chem™ RS500P and RA500M
<b>Environment</b>	Salt water strainer
<b>Challenge</b>	Removal of heavy corrosion. Holes identified through the body and heavy localised pitting, particularly in the O ring groove sealing ring area. Weld repairs were carried out prior to further hot washing and re-abrasive blasting.
<b>Chemco's Solution</b>	Repeat abrasive blasting and hot washing to reduce metallic salts below 25 ppm. Pit filling of deep metal loss and  Abrasive blast to AS 1627.4 Class 2.5, nominal 75µm profile.  Application of RS500P, then two coats of RA500M Series to obtain minimum thickness of 500µm  Cast sealing ring for O ring groove rebuilding the original surface profile using  Carry out QA, spark test at 4kV and DFT to confirm coating integrity.
<b>Scope</b>	High pressure hot wash and repeat abrasive blast to reduce soluble salt levels below 25ppm

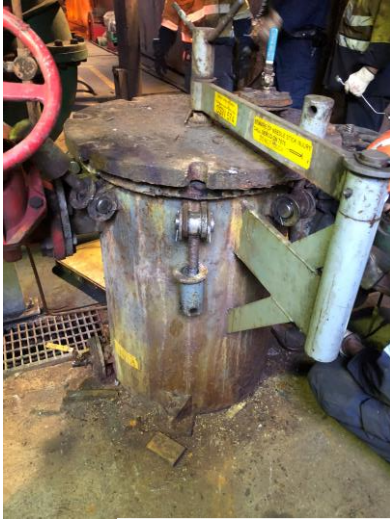
On Arrival

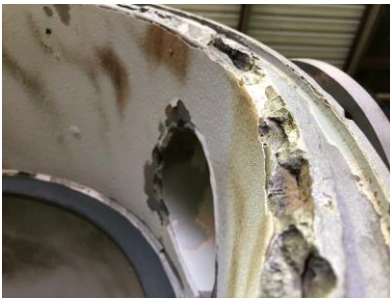
O ring groove after initial abrasive blast

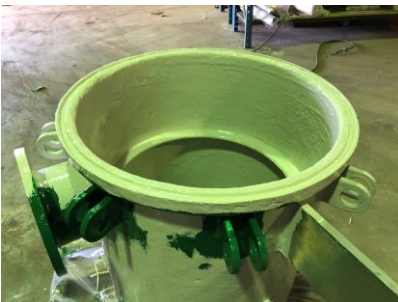
After 2<sup>nd</sup> blast and 2 hot washes

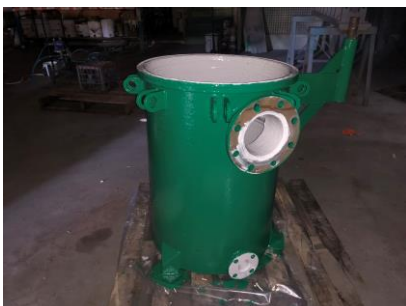
Completed

<b>Results</b>	Quick turn-around allowing minimal disruption to meet project milestone targets.  Strict QA requirements including DFT and holiday testing to the required voltage to ensure many years of high performance
