Client: <i>Hanson Marine</i>	Industry: <i>Marine</i>
Vessel: <i>Dredger</i>	Date: <i>May 2013</i>
Location: <i>Antwerp, Belgium</i>	Products: <i>RS 500P & Chem-glide™ RA 500CG</i>

The internal surface of the kort nozzle of the MV Arco Arun was suffering from galvanic corrosion, abrasion and erosion and required a new foul release coating system. The client was also looking for a highly abrasive and chemically resistant coating system for their vessel's rudder to replace the existing anti-fouling which had failed.

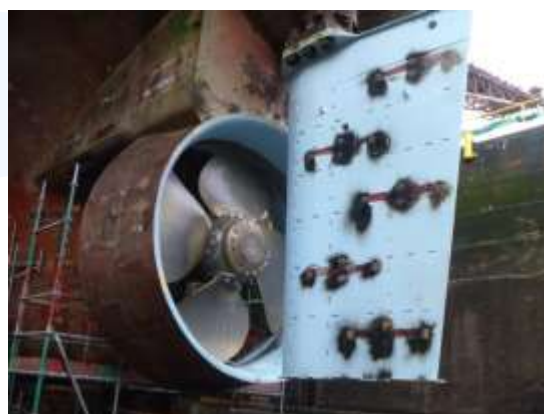
- No. 1 After 18 months in service
- Nos. 2-3 Completed application

The vessel was brought to dry-dock with the Chemco system and a major top-selling anti-fouling being in operation for 18 months. After HP cleaning, the Kort nozzle and rudder were in 'as good as new' condition. The only maintenance requirements were small touch-up areas where mechanical damage had occurred. The half of the rudder coated with an industry leading anti-fouling was showing signs of extensive fouling and corrosion damage. This conventional system also lifted from the surface of the hull during cleaning, resulting in high maintenance costs for repair.

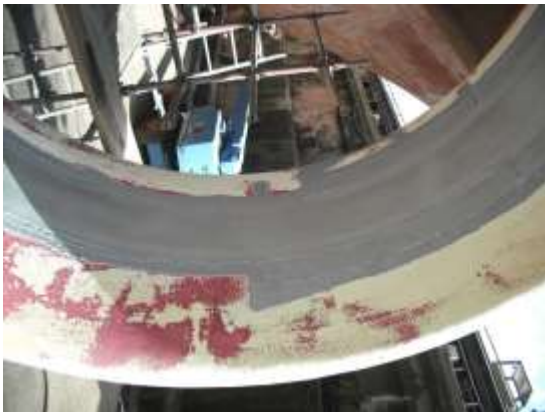
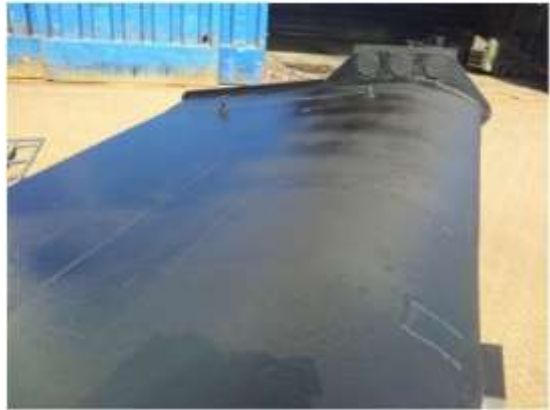
- Nos. 4-5 After surface preparation
- Nos. 6-7 After priming with Epo-chem™ RS 500P
